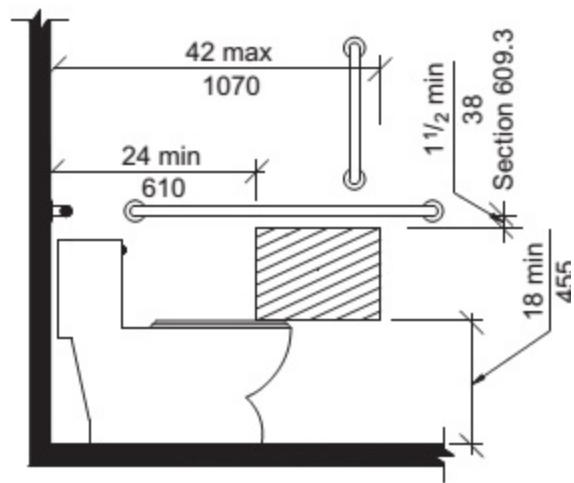
(a) Protruding Dispenser Below Grab Bar

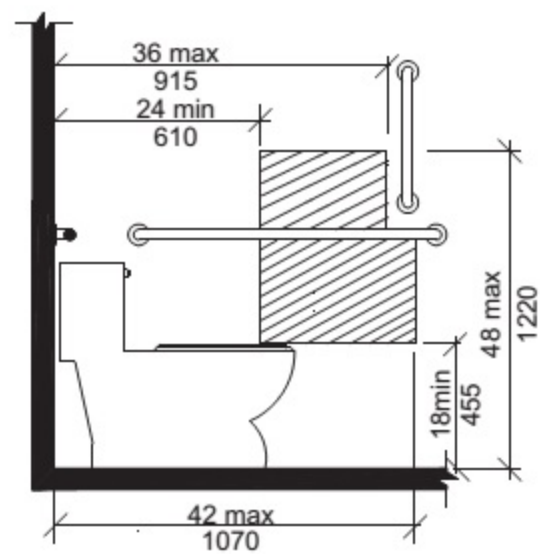
(c) Recessed Dispenser

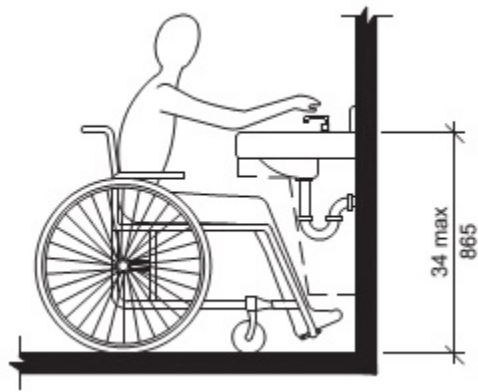
FIGURE 606.3  
HEIGHT OF LAVATORIES AND SINKS

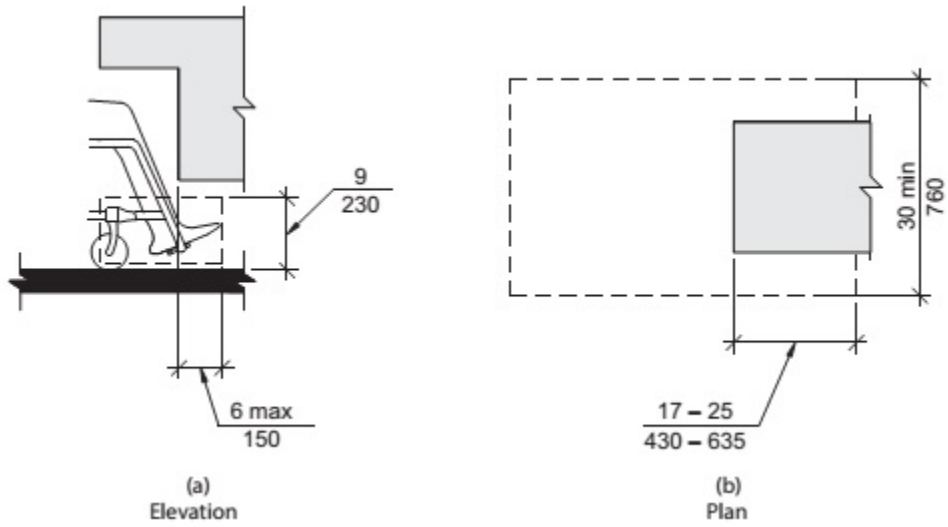
FIGURE 306.2  
TOE CLEARANCE

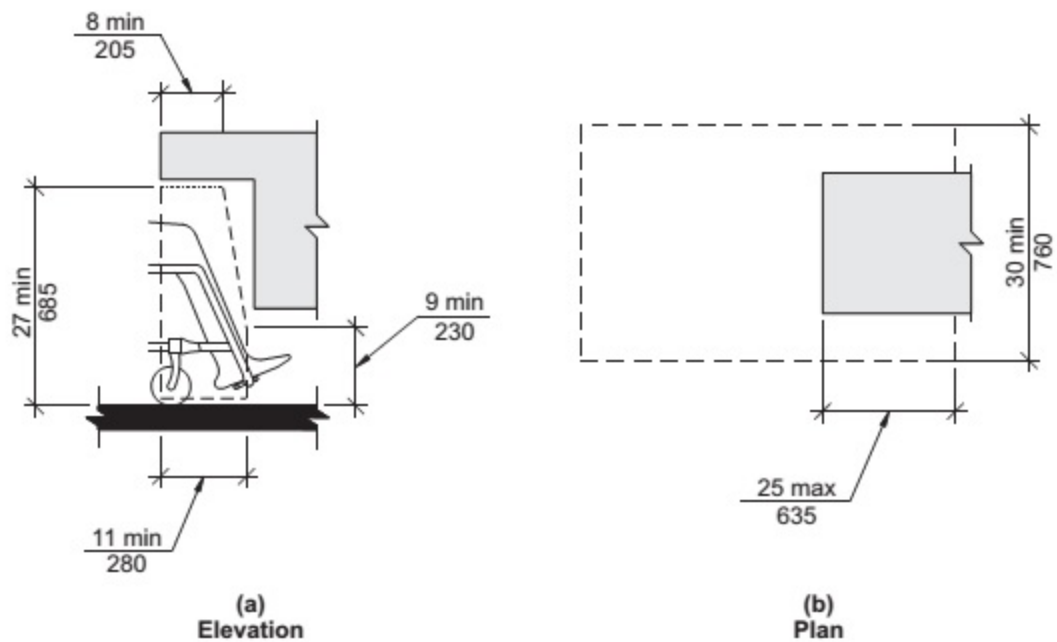
FIGURE 306.3  
KNEE CLEARANCE
